Structural and Hygrothermal Field Monitoring of Thick Continuously Insulated Wall Assemblies Utilized in a Multi-Story Residential Building

ABSTRACT

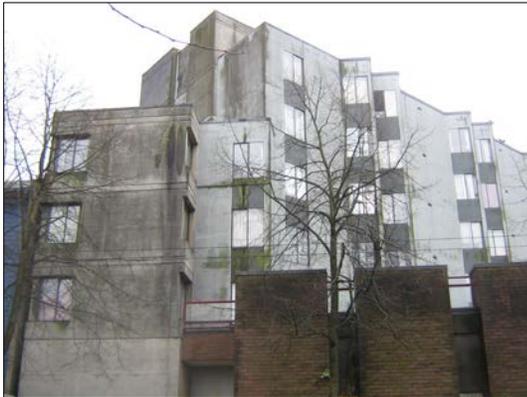
FIGURE 1 - North Elevation Before Repairs

The subject building is a 64-unit social housing complex in a seven story reinforced concrete structure, with steel stud infill walls and commercial space on the first floor. The original envelope assemblies included cement stucco on steel-stud-infill walls, exposed mass concrete, brick at the first floor front elevation, and built-up roof systems on main and terrace-level roofs. Ongoing moisture-related problems (mainly at windows and wall assemblies), ageing roofs, and problematic integrations led to the need for comprehensive rehabilitation. The rehabilitation project commenced in the spring of 2010 and was completed in the spring of 2011 (FIGURE 1 and FIGURE 2).

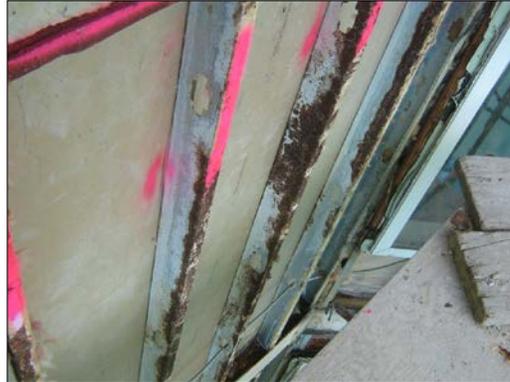
FIGURE 3 - Extensive steel stud damage

revealed extensively deteriorated steel studs and moisture-affected drywall (see FIGURE 4). Stud shadowing due to temperature variations from more conductive steel studs was apparent from both the interior and the exterior. Though a remediation strategy involving selective steel stud replacement and repairs was contemplated, due to the extent of damage, the project team determined that it would be more cost effective to completely demolish large portions of the walls and install new tracks, studs and drywall.

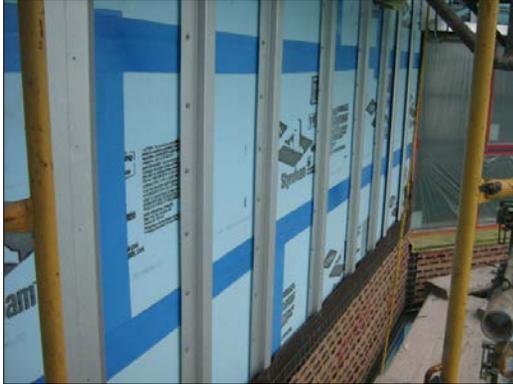
FIGURE 5 - Galvalume Z-girts on 3" rigid XPS

Though common practice, cutting and fitting of rigid insulation around installed Z-girts can reduce the wall's effective insulation R-value by more than half. Table A3.3 from ASHRAE 90.1- 2007 demonstrates the impact of steel framing on the effective insulation values. In the assembly described above, the Z-girts are installed over the insulation instead and attached with screws back to the steel studs through the insulation and sheathing. Because the screw fasteners are the only metal components that penetrate through the insulation, the assembly conforms to the definition of continuous insulation mandated by many North American energy codes. The Z-girts are installed tight to the insulation and designed to be rigid enough to transfer gravity and wind loads to the insulation (see FIGURE 5).

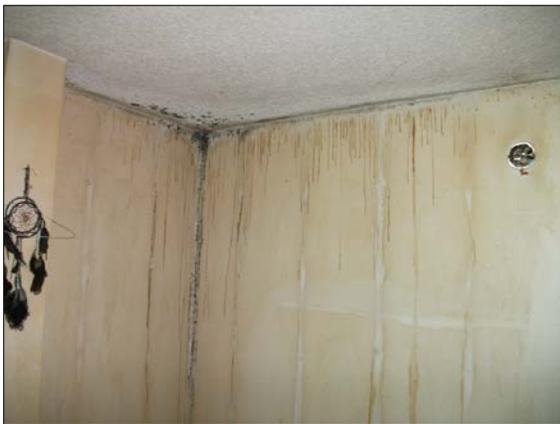
FIGURE 6 - Interior Moisture Damage Related to Condensation and Leakage

In addition, eliminating the penetration of metal framing through the insulation reduces the thermal bridging that can lead to stud shadowing and increased risk of condensation (see FIGURE 6).

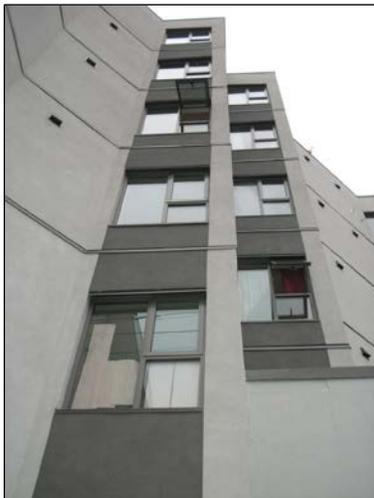
FIGURE 9 - Completed Continuously Insulated Rain Screen Stucco System

The scaffolding and netting was removed in late December 2010 and early January 2011. The cladding replacement project was substantially complete on March 4, 2011 (see FIGURE 9).

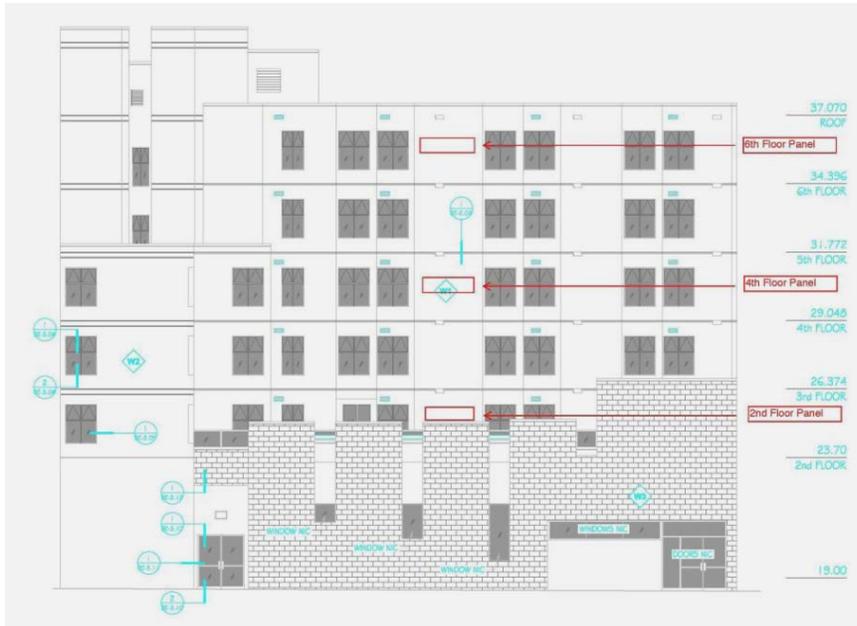
FIGURE 10 - Measurement Panel Locations (North Elevation)

Building position measurements were taken on the south and north façades of the building, with sensors located on the second, fourth and sixth floors. Multiple floor

locations were chosen to provide building dimensional change data as a function of building height, whereas locations on opposite façade orientations provided displacement data as a function of building exposure. Locations of measurement panels are indicated by the red squares in FIGURE 10 and FIGURE 11 below. Six insulation boards were instrumented for this case study. Information from three panels is reported, the north wall second floor and the south wall second and fourth floors. Information from the remaining three panels is not reported, as data was not consistently collected throughout the entire test period due to periodic data acquisition system outages.
